Terraprobe

PHASE ONE ENVIRONMENTAL SITE ASSESSMENT INTERSECTION OF PEARSON DRIVE AND ESTEN DRIVE NORTH ELLIOT LAKE, ONTARIO

File No 5-21-0300-41
April 27, 2022

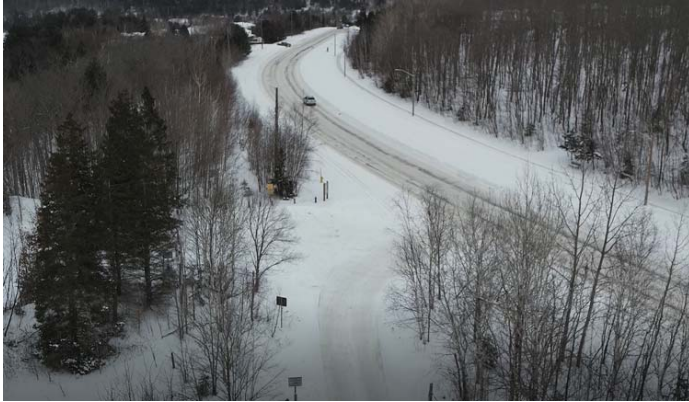
Photograph 1

Location: Entrance to Phase I Property
Viewing: Northeast

Description: Viewing from the entrance to the Property from Esten Drive North. Esten Drive is a paved road while the entrance to the Property is gravel (based on google maps).

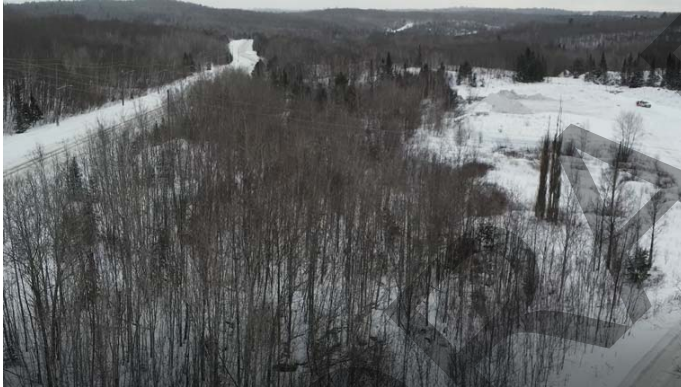
Photograph 2

Location: Phase I Property
Viewing: South

Description: Viewing of east side of the Property. Surrounded by trees and bushes. The ground elevation is uneven.

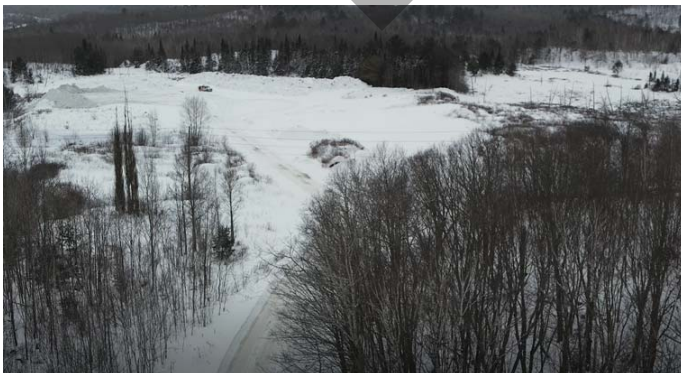
Photograph 3

Stressed Vegetation	No stressed vegetation was identified on the Property during the site visit.
Fill Materials	Fill material was identified on the east-central portion of the Property. Area was used as a snow dump.
Potentially Contaminating Activity	An electrical substation was observed on the northern portion of the Property.
Unidentified Substances	Terraprobe did not observe any unidentified substances during the site visit.

Location: Phase I Property
Viewing: South

Description: Viewing of the central portion of the Property. Accessible by a vehicle and is used as a snow dump site.

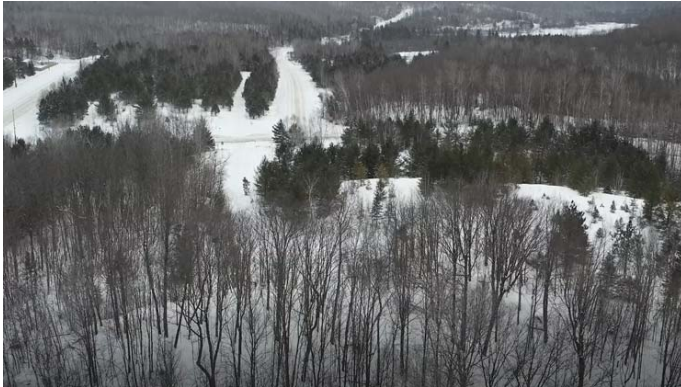
Photograph 4

Location: Phase I Property

Viewing: South

Description: Viewing of the south side of the Property. Left side of the image shows the intersection between Esten Drive North and Pearson Drive. Property contains several trees, bushes, and a trail road.

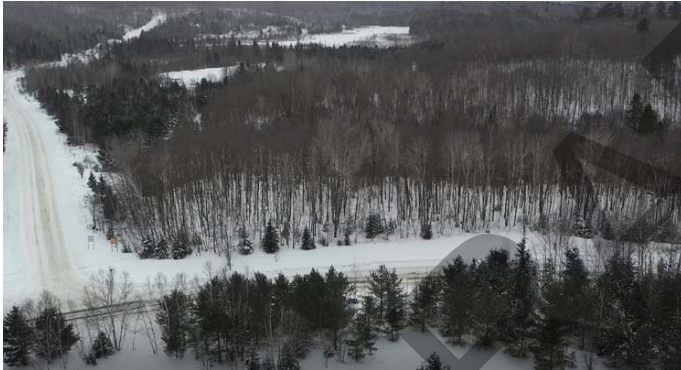
Photograph 5

Location: Phase 1 Property

Viewing: South

Description: Viewing of the portion of the Property across Pearson Drive. Property is surrounded by trees and bushes.

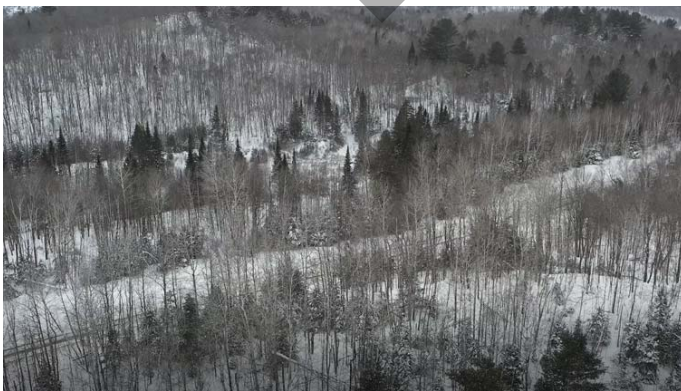
Photograph 6

Location: Phase I Property

Viewing: Southwest

Description: Viewing of the Property with Pearson Drive. A lot of trees and bushes covering the area.

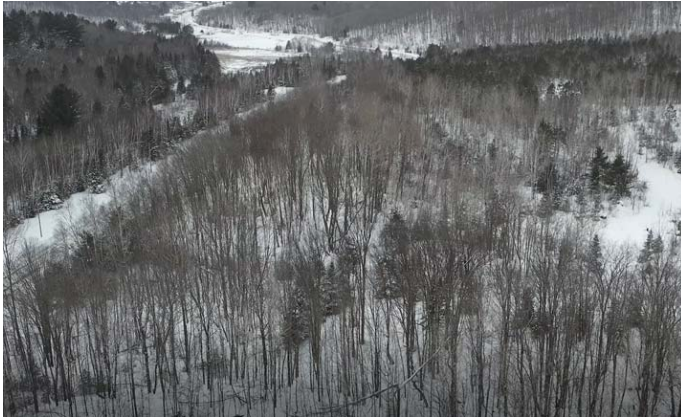
Photograph 7

Location: Phase 1 Property

Viewing: West

Description: Viewing of the west side of the Property. Pearson Drive is located on the left side of the image. A lot of trees and bushes covering the area.

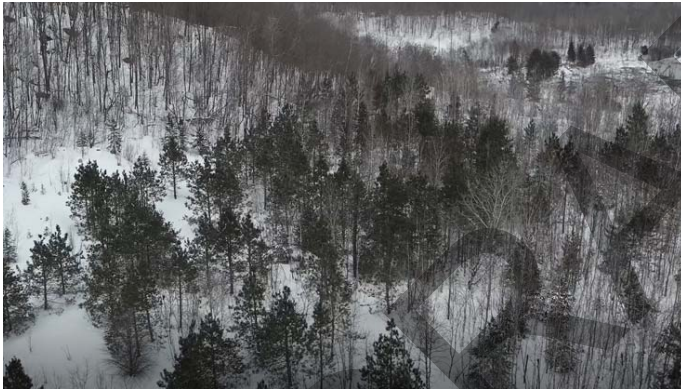
Photograph 8

Location: Phase I Property

Viewing: Northwest

Description: Viewing of the northwest side of the Property. Higher elevation of land on the northwest side covered with trees and bushes.

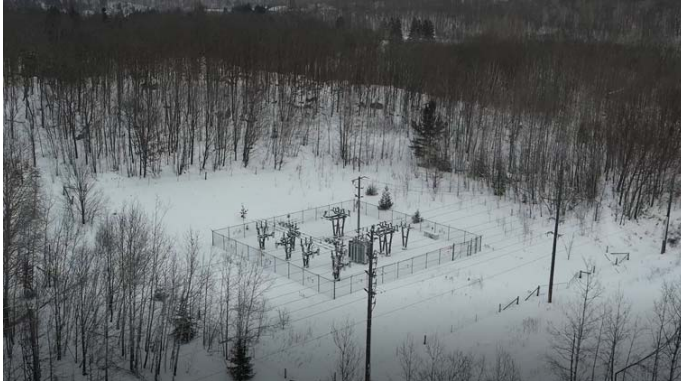
Photograph 10

PCBs	An electrical substation was observed on the north side portion of the Property. Possible PCBs contamination.
Ozone Depleting Substances	No ozone- depleting substances were observed during the site inspection.
UFFI	No UFFI products were observed during the site inspection.
Mould	No mould or areas of excessive dampness were observed during the site inspection.
Radioactive Materials	No manmade sources of radiation were observed during the site inspection.
Herbicides and Pesticides	No materials containing herbicides or pesticides were observed to be stored or used at the site

Location: Phase I Property

Viewing: Northeast

Description: Viewing of a substation located on the northern side of the Property. Accessible by a trail road connected to Esten Drive North.
