Terraprobe

D-4 LANDFILL IMPACT ASSESSMENT INTERSECTION OF PEARSON DRIVE AND ESTEN DRIVE NORTH ELLIOT LAKE, ONTARIO

File No 5-21-0300-54

Date: May 30, 2022

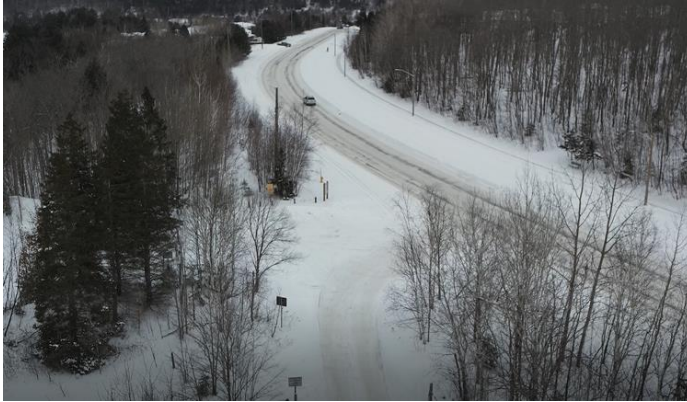
Photograph 1

Location: Entrance to D4 Property

Viewing: Northeast

Description: Viewing from the entrance to the Property from Esten Drive North. Esten Drive is a paved road while the entrance to the Property is gravel (based on google maps).

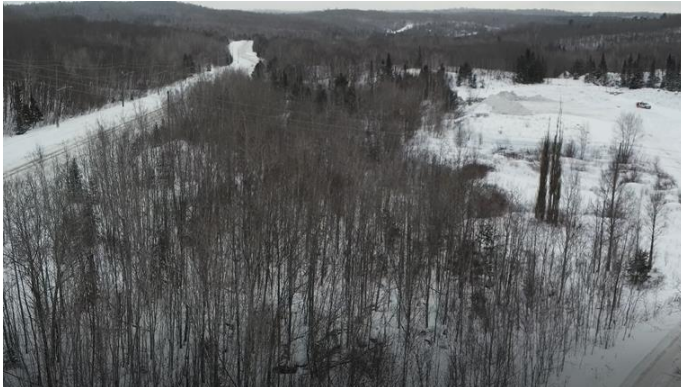
Photograph 2

Location: D4 Property

Viewing: South

Description: Viewing of east side of the Property. Surrounded by trees and bushes. The ground elevation is uneven.

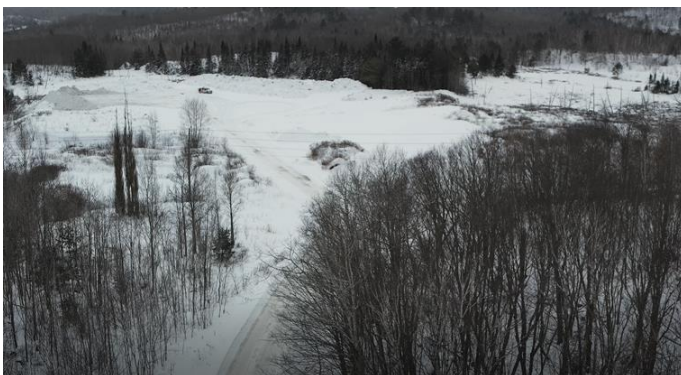
Photograph 3

Location: D4 Property

Viewing: South

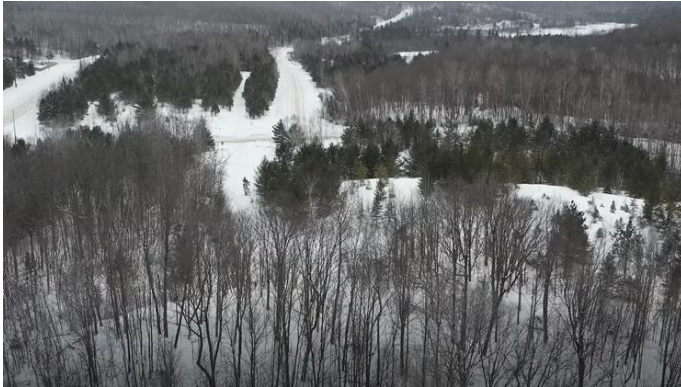
Photograph 4

Location: D4 Property

Viewing: South

Description: Viewing of the south side of the Property. Left side of the image shows the intersection between Esten Drive North and Pearson Drive. Property covered with several trees, bushes, and a trail road.

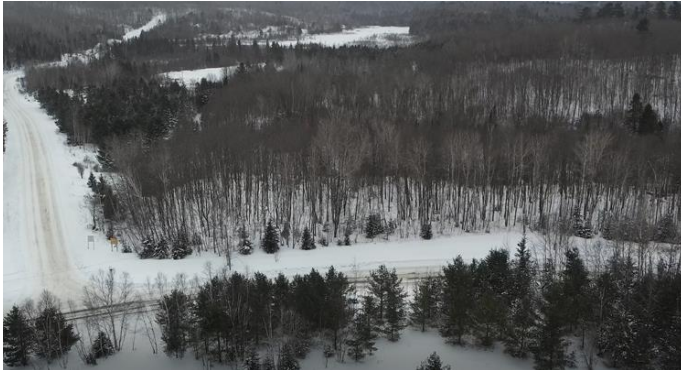
Photograph 5

Location: D4 Property

Viewing: South

Description: Viewing of the portion of the Property across Pearson Drive. Property is surrounded by trees and bushes.

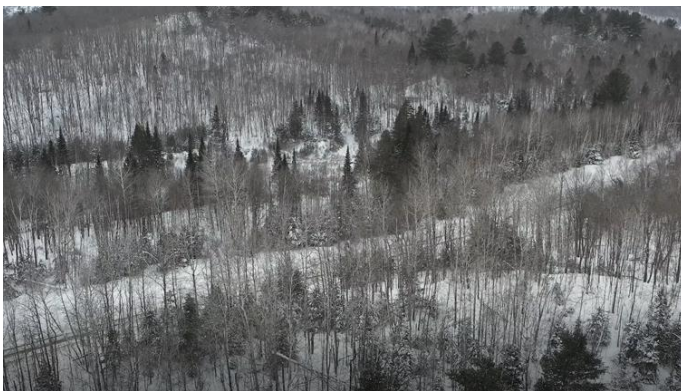
Photograph 6

Location: D4 Property

Viewing: Southwest

Description: Viewing of the Property with Pearson Drive. Trees and bushes covering the area.

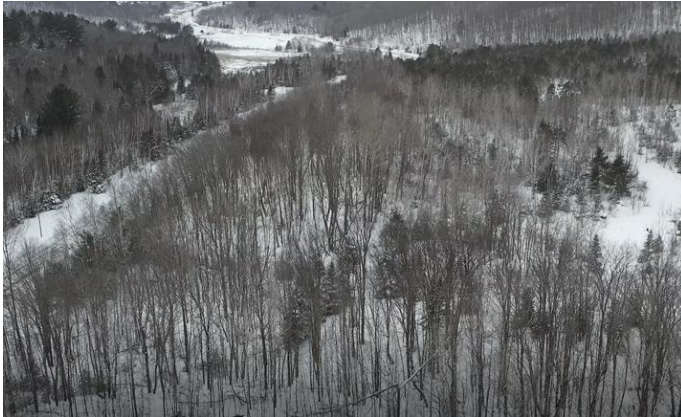
Photograph 7

Location: D4 Property

Viewing: West

Description: Viewing of the west side of the Property. Pearson Drive is located on the left side of the image. A lot of trees and bushes covering the area.

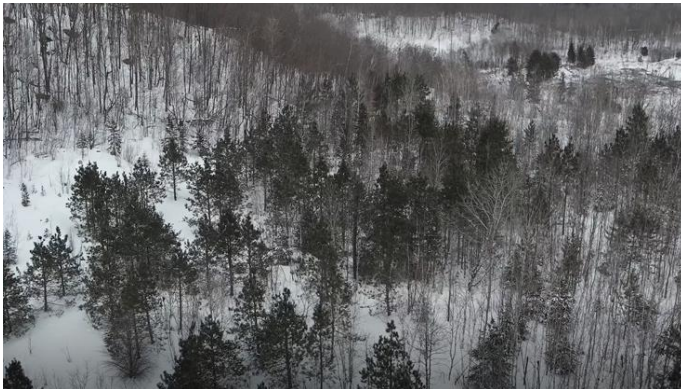
Photograph 8

Location: D Property

Viewing: Northwest

Description: Viewing of the northwest side of the Property. Higher elevation of land on the northwest side covered with trees and bushes.

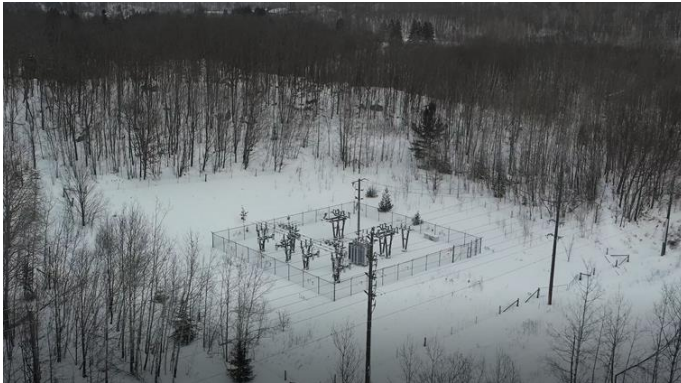
Photograph 10

Location: D4 Property

Viewing: Northeast

Description: Viewing of a substation located on the northern side of the Property. Accessible by a trail road connected to Esten Drive North.

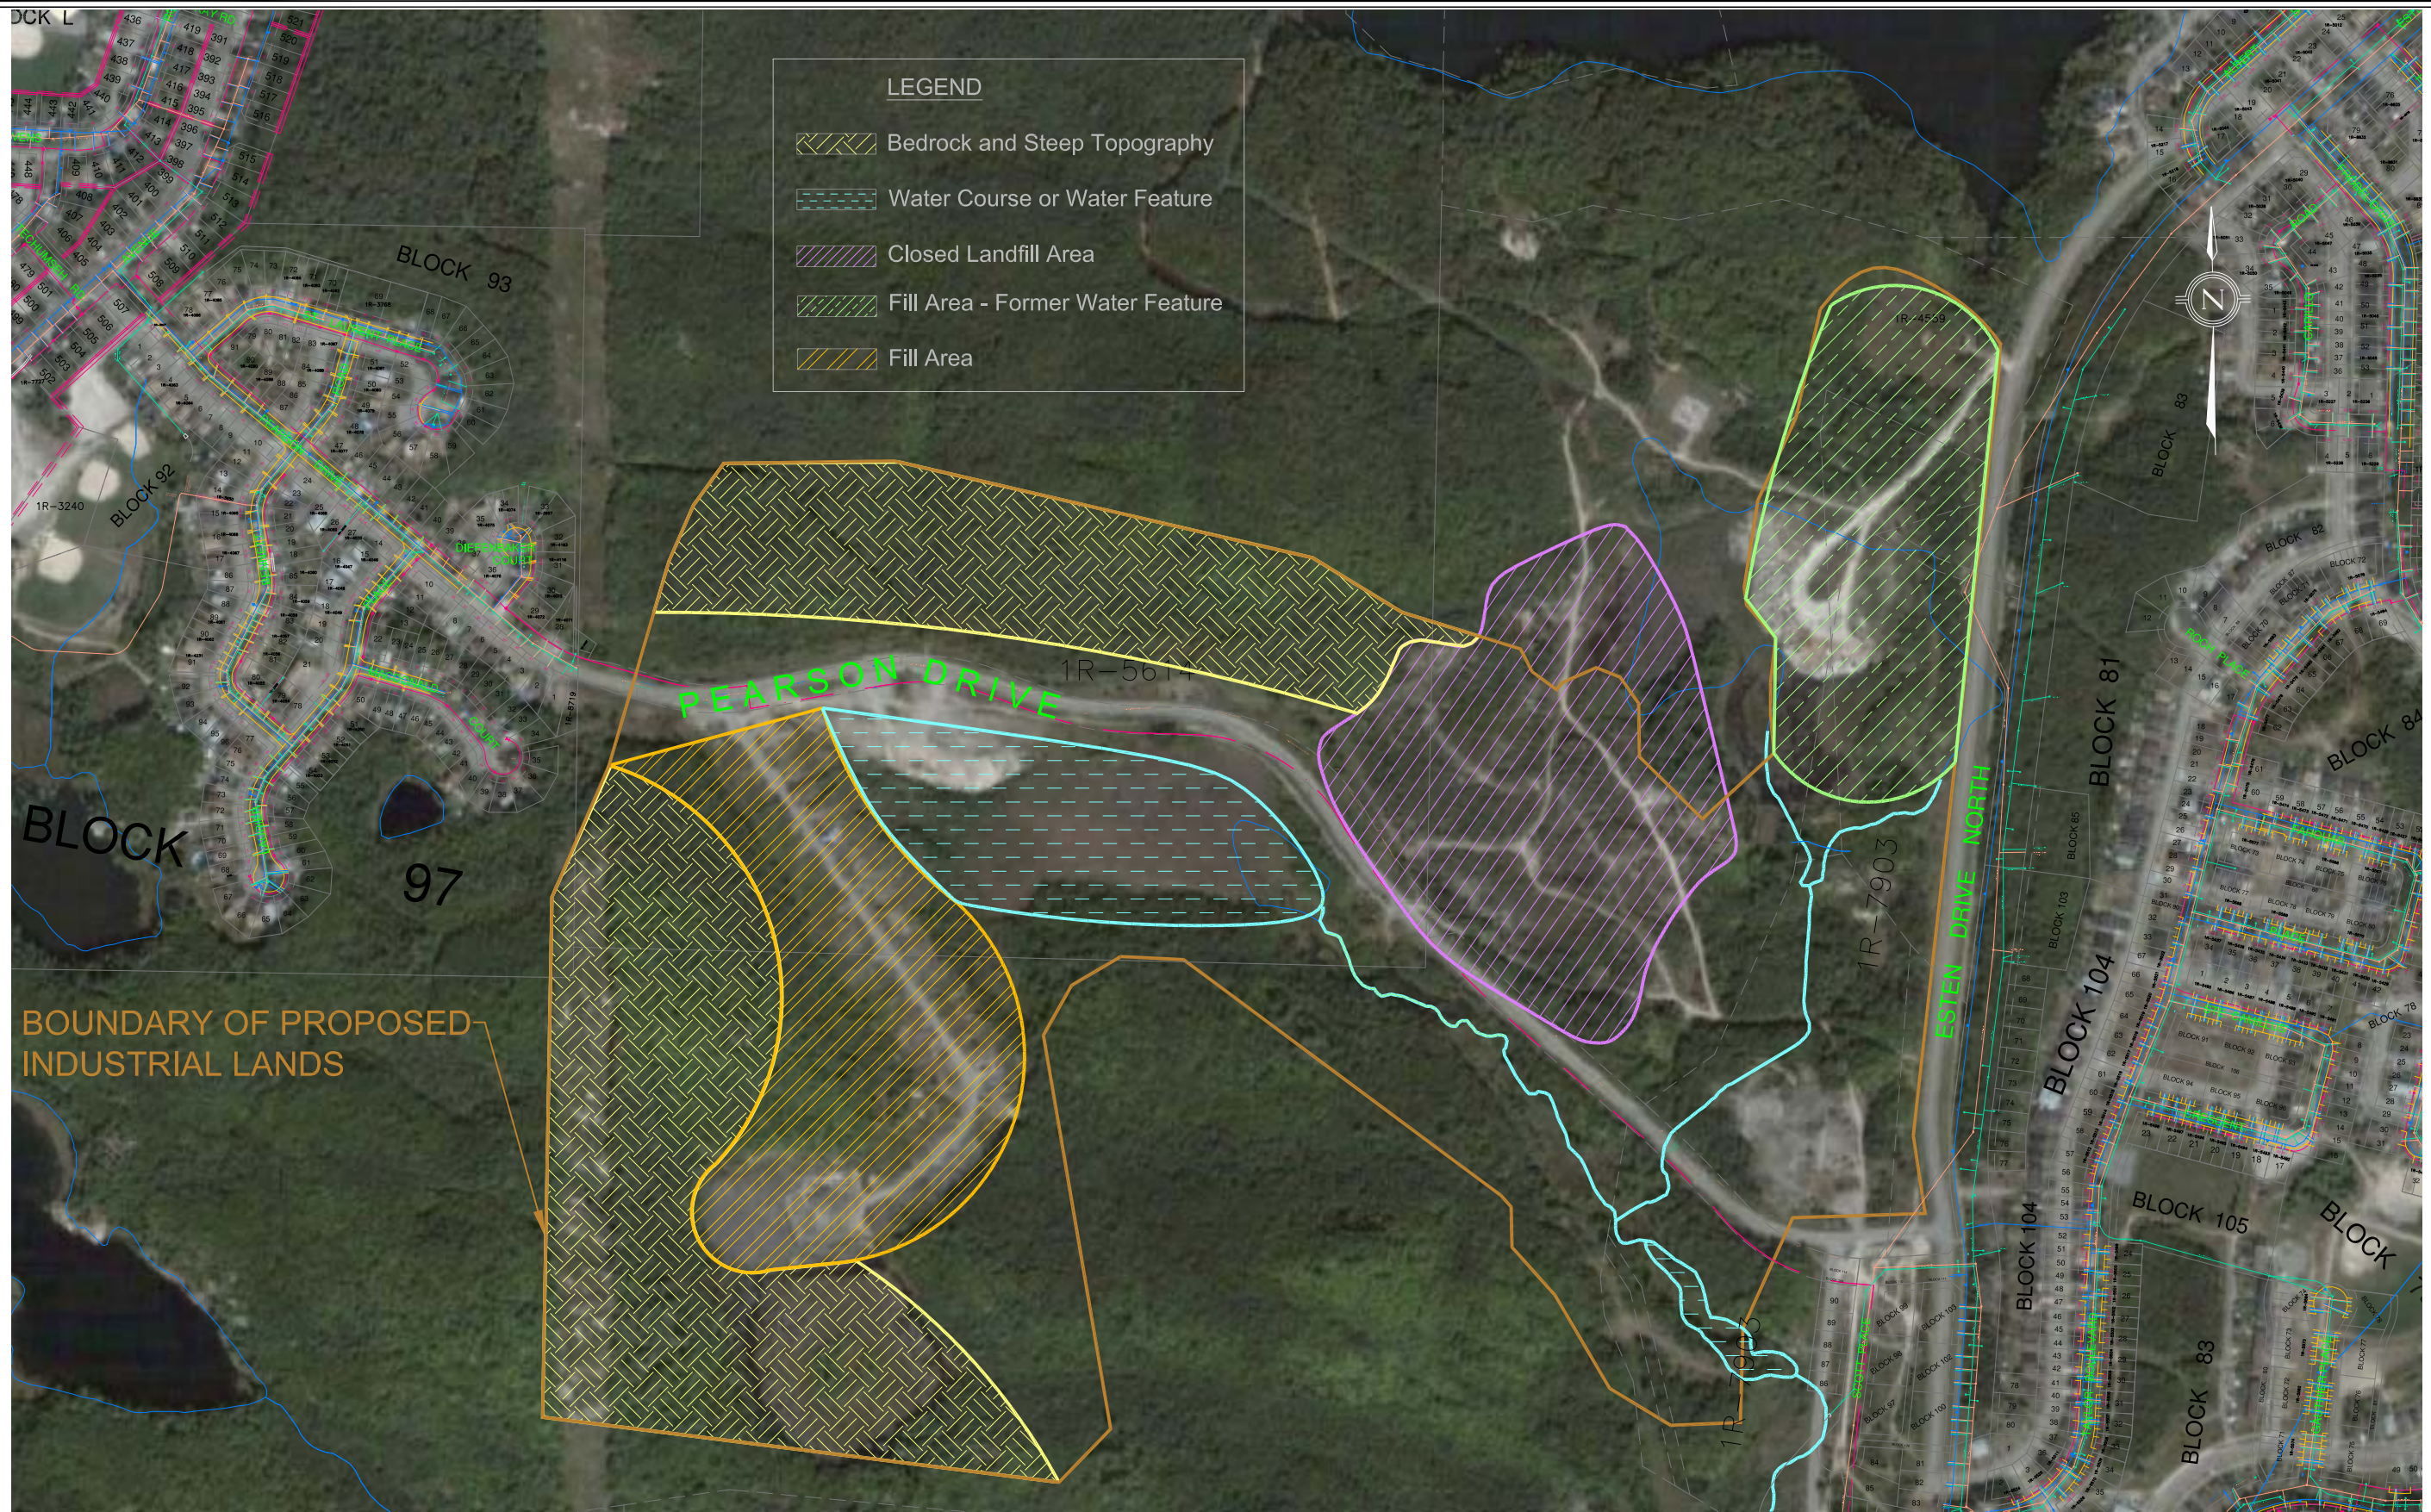
FIGURE 3

STUDY AREA - BASE MAP

It is evident that there has been previous activity within the site area, in addition to those related to the landfill. In particular, it appears that a shallow pond or marsh once existed immediately to the north and east of the landfill. This feature is evident on Ontario Base Mapping from 1986 (Figure 3). This feature has now been filled. There are an access roadway and several paths and ATV trails which lead through this area.

Site geology was assessed on the basis of geologic mapping and the results of subsurface investigations conducted by others (CRA 1980). The locations of boreholes drilled at the site by CRA are shown on the accompanying Figure 3. These investigations indicate that the northern portion of the site generally consists of bedrock outcrops of granodiorite and metasedimentary rocks. The central and southern portion of the property is covered with a mixture of glacial deposits. The glacial deposits are variable in nature, but typically consist of coarse granular material (sand or sand and gravel). There are occasional layers of finer materials such as silt and silty sand glacial till.

There is no evidence of waste or refuse exposed over the site. Locally, there is evidence of random surface dumping of small piles of debris or waste such as tires. The approximate extent of the waste was determined by CRA in 1980. The determination was based on site inspection and excavation of a number of shallow test pits. The locations of the test pits are shown on the accompanying Figure 3. Based on these studies, the approximate boundary of the waste disposal area, as determined by CRA, is also shown on Figure 3.
